Sonic Anemometer Angle of Attack Errors

J. Kochendorfer, T. Meyers and M. Heuer

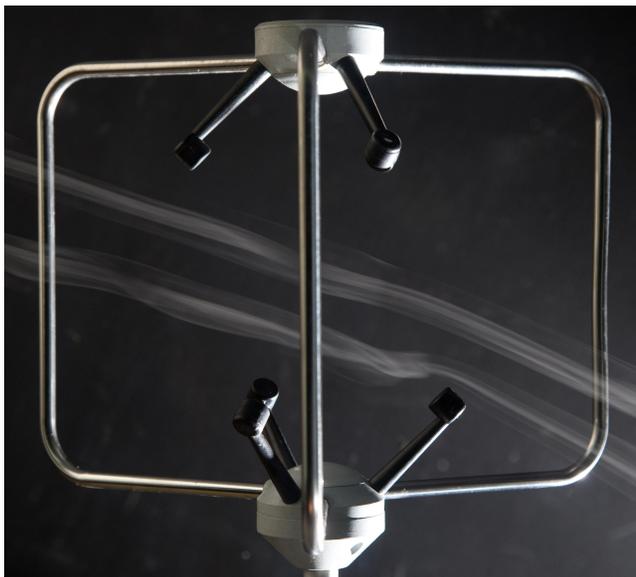
Figure 1. Photograph of a transducer wake in laminar wind tunnel flow.

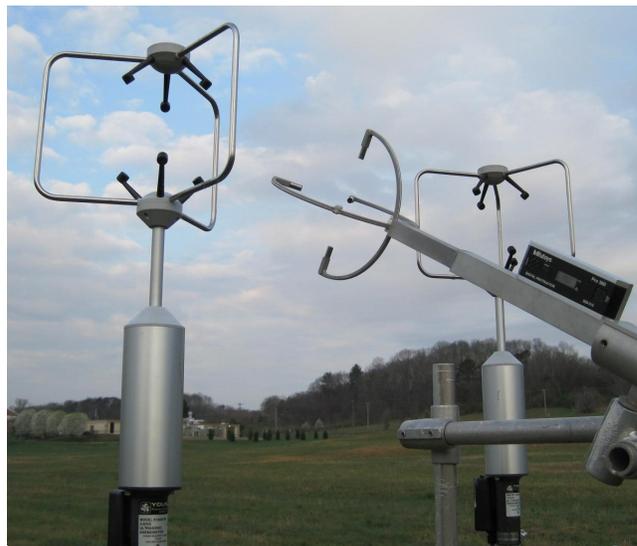
Figure 2. Photograph of the Applied Technologies sensor (center) tilted 30° during the experiment.

Angle of attack or (co)sine errors are caused by the wakes formed downwind of sonic anemometer transducers. These errors occur when the vertical component of the wind velocity is non-zero, and they cause underestimation of the measured vertical wind speed. The importance of (co)sine errors in eddy covariance based mass and energy budgets have been established by past wind tunnel studies. In more recent field studies, these errors have been quantified in turbulent surface-layer flows. In the present study, (co)sine errors were estimated for over 100 combinations of angle of attack and wind direction using an RM-Young (8100VRE) sonic anemometer and a novel technique to measure the true angle of attack and the wind velocity within the turbulent surface layer. Corrections to the vertical wind speed varied from -5% to 37% for all angles of attack and wind directions examined. When applied to eddy covariance data from two Ameriflux sites, the (co)sine error corrections increased the magnitude of CO₂ fluxes, sensible heat fluxes, and latent heat fluxes by ca. 10%. A sonic anemometer designed with one pair of transducers aligned with the vertical axis (Applied Technologies, Inc., "VX" style) was also tested at four angles of attack (Fig. 2). Corrections to the vertical wind speed measured using this anemometer were within $\pm 1\%$ of zero. Sensible heat fluxes measured using the Applied Technologies anemometer were ca. 9% greater than fluxes of sensible heat fluxes measured using the RM-Young (Fig. 1), Gill, and CSAT anemometers, should be redesigned to allow for measurement of the vertical velocity using one pair of vertically aligned transducers, like the "Vx" style Applied Technologies anemometer (Fig. 2).
